# Mechanics of Advanced Composite Structures

# Effect of ON and OFF Axis Open Hole Tensile Testing of GFRP/Epoxy Composites

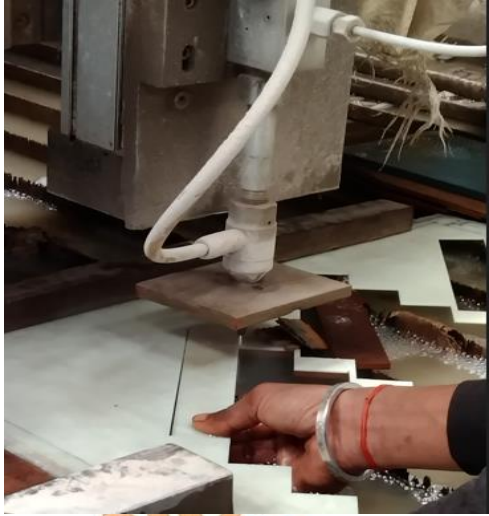
Fig. 3. a. Waterjet cutting off-axis (45°) Orientation

The specimens for the on-axis were cut normally as per the above dimensions, however for the off-axis, the cutting direction was at  $45^\circ$  as shown in Figure 3a. The laminate after being cut was drilled at the center as per the w/D ratio 6 mentioned in the ASTM standards [18]. In the present study, the effect of this ratio is studied which was varied from 2 to 6 resulting in different diameters namely (6, 9, 12, and 18 mm) using a cemented carbide twist drill with different diameters and a spindle speed of 4500 rpm and a feed rate of 110mm/min to carry out the drilling using a VMC Drilling Machine [30]. The machining parameters were chosen according to the standard drill size suitable for joining the laminates. The speed was maintained at 4500 rpm to reduce the delamination effect. Sufficient care was taken to ensure the specimens were sandwiched between two GFRP laminates, mainly to reduce the drilling-induced

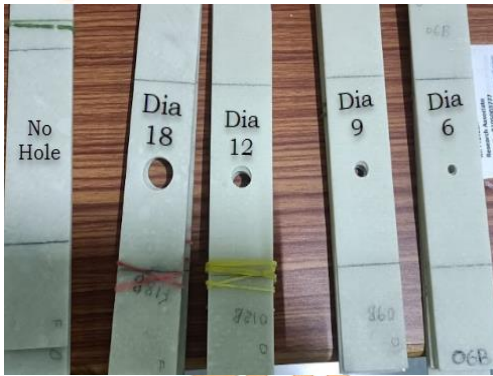
Fig. 3. b. Specimen with drilled holes

damages in and around the hole region. The specimen notation is shown in Table 1 and drilled specimens are shown in Figure 3b.

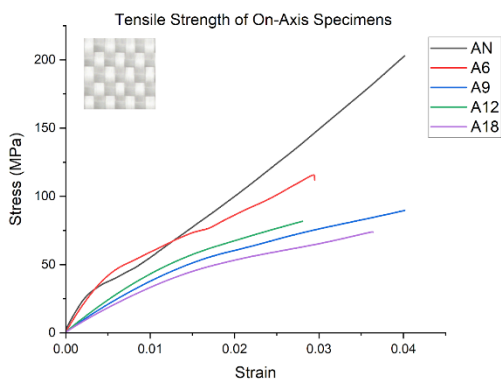
Fig. 5. On-axis tensile test results

All the samples underwent linear deformation at lower stress levels and started to behave non-linearly at higher stress levels, as shown in Figure 5, leading to failure around the hole region. The mechanical behavior of various specimens under stress was analyzed, focusing on deformation and failure patterns. Figure 5 illustrates that all samples initially underwent linear deformation at lower stress levels before transitioning to non-linear behavior, leading predominantly to failure around the hole region. This aligns with findings in previous studies [8,9]. Peak load values are

pivotal in understanding the impact of structural modifications, such as hole introduction, on material integrity. The hole-less specimen AN, with the highest peak load of 16.082 kN, serves as a reference. In contrast, specimens A6, A9, A12, and A18 with holes show significant peak load reductions of 40.42%, 51.46%, 59.74%, and 65.23%, respectively. In a study done by O'Higgins et al. [28], it was found that the percentage reduction between unholed and holed specimens was almost 50%. This indicates a clear correlation between increasing hole size and decreased peak load capacity, which is essential in load-bearing applications, highlighting the trade-off between design elements and mechanical strength.

Tensile strength analysis, though complicated by different metrics ( $\sigma_{UH}$  for AN and  $\sigma_H$  for others), reveals a consistent pattern. Compared to AN's  $\sigma_{UH}$  of 203.063 Mpa, there's a marked decrease in tensile strength in specimens with holes: 43.01% for A6, 53.58% for A9, 59.73% for A12, and 63.57% for A18. This trend suggests that larger holes significantly compromise material strength, with holes acting as stress concentrators, causing damage and reduced tensile resistance.
